## Hitachi TM3000 - SEM Exploration Activity

### SafeSense

SEM Exploration – Specimen Analysis Sheet

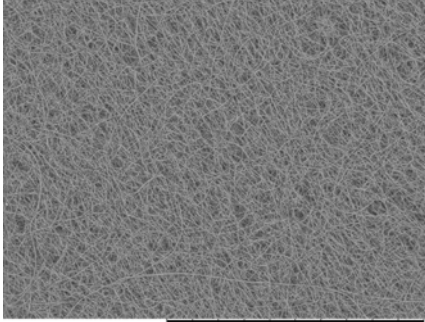
**100X**

SafeSense 0000 2014/03/03 10:02 A.L D5.6 x100 1 mm  
D (Waterlock)

- Small but visible fibers
- Small pockets of air
- Randomly assembled

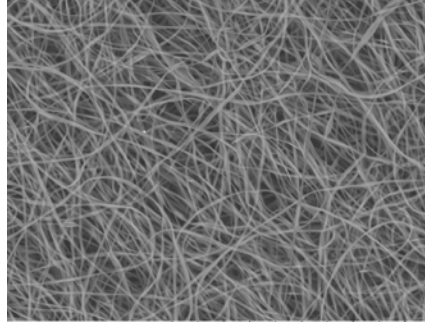
**500X**

SafeSense 0001 2014/03/03 10:05 A.L D5.6 x500 200 um  
D (Waterlock)

- Dense (more fibers)
- Look similar to PMMA

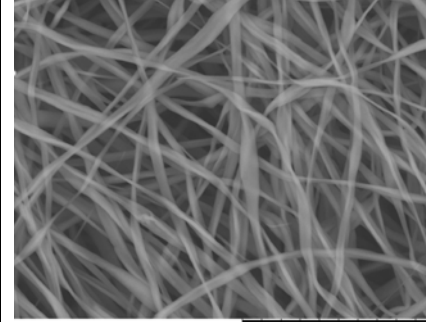
**1500X**

SafeSense 0002 2014/03/03 10:07 A.L D5.6 x1.5k 50 um  
D (Waterlock)

- Transparent fibers
- Wavy
- Seem to be easy to manipulate/bend/squish

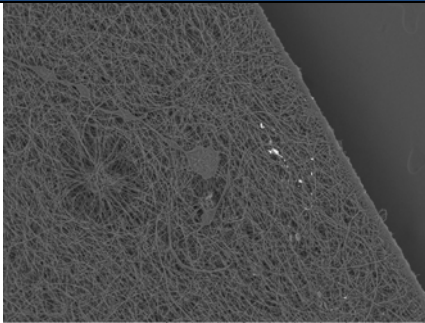
**100X**

SafeSense 0003 2014/03/03 10:11 A.L D5.4 x100 1 mm  
D (Waterlock)

- Could be where water fell on the fibers
- Bunch together in two spots

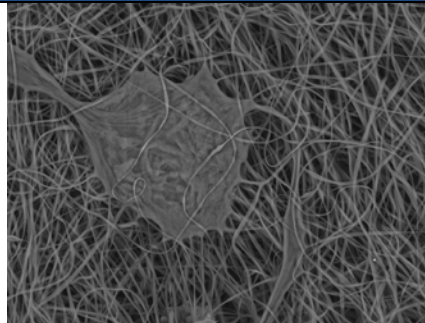
**500X**

SafeSense 0004 2014/03/03 10:13 A.L D5.4 x500 200 um  
D (Waterlock)

- Fibers branching off
- Water could have been absorbed which led them to be bunched together

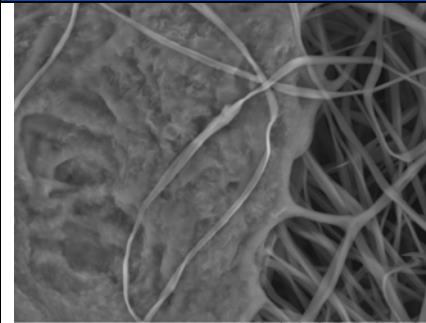
**1500X**

SafeSense 0005 2014/03/03 10:14 A.L D5.4 x1.5k 50 um  
D (Waterlock)
